Manhole Inspection Summary

Manhole # S55A__002MH

Insp Date: **6/12/09 4:40 PM**

Location Address: **3700 PULASKI HWY**

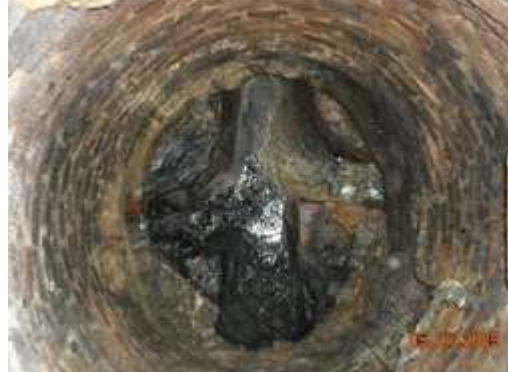
Top View

AFTER SPCL WAS DONE. CHANNELS AT 3:00, 6:00, & 9:00 WERE OPENED VIA SPCL.

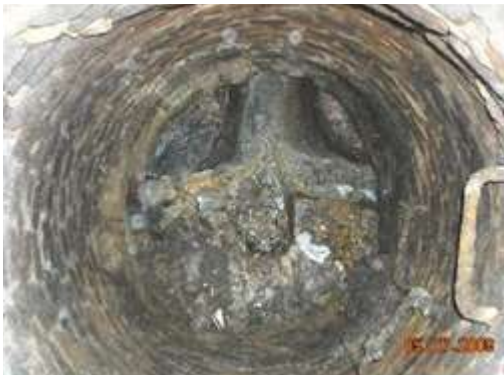
Miscellaneous

MISC. TOP VIEW PRIOR TO SPCL.

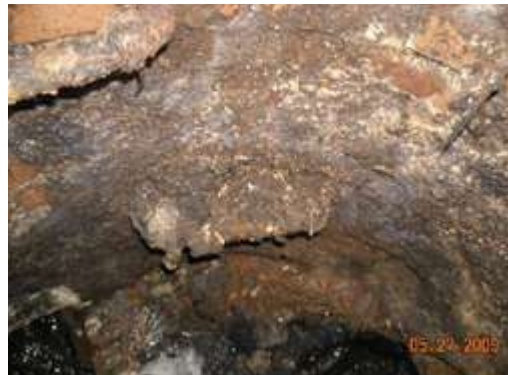
Defect 4

Count: **3** Missing: **0** ☒ **Corroded**

corroded steps

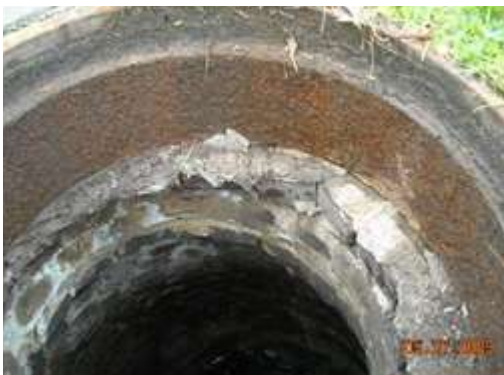
Defect 3

Offset: **2** (in.)

Condition: ☐ Sound ☐ Cracked ☐ Root Intrusion ☐ Loose Brick ☒ **Deteriorated**

chimney deteriorated; frame offset

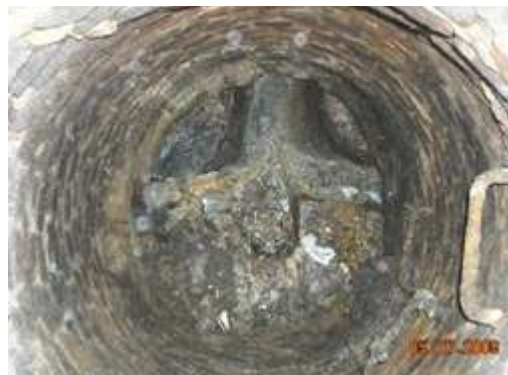
Defect 2

Condition: ☐ Sound ☐ Cracked ☐ Root Intrusion ☐ Deteriorated ☐ Leaks ☒ **Debris**

☒ **Evidence Of Surcharge** Depth: **4** (ft.) ☐ Active Surcharge Present

evidence of surcharge; channel & bench debris

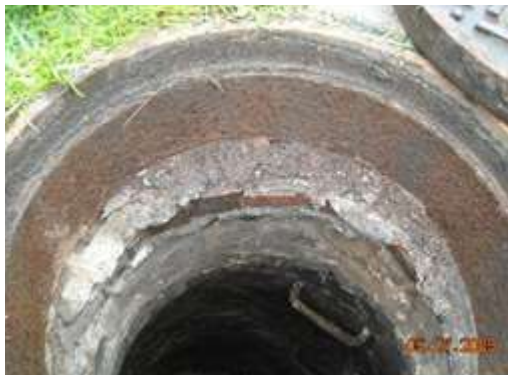
Defect 1

☒ **Leaks**

FRAME: LEAKS

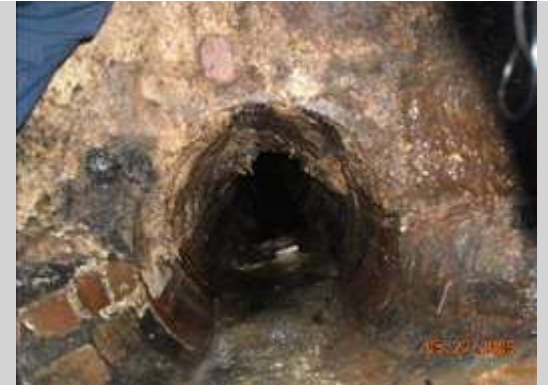
12 O'Clock Outflow

Pipe Height: **10.8** (in.) Rod and Bar (Angled)
Pipe Material: **Clay** ☐ Pipe Lined
Invert Depth: **7.50** (ft.) Flow Characteristics: **Slow**
Deposits: ☐ None ☒ **Mud** ☒ **Sludge** ☒ **Debris** ☒ **Grease**
Silt Depth: **3** (in.) Deposits Extent: **Medium**
Infiltration: **None** Pipe Seal Cond: **Sound**

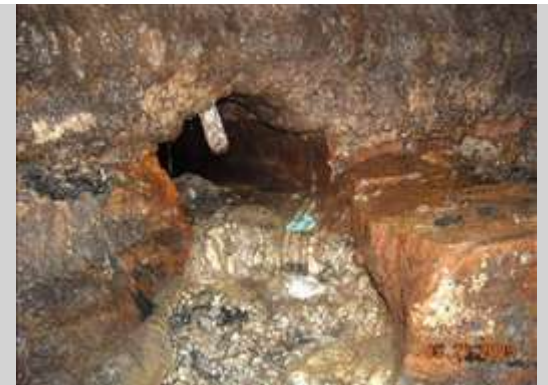
3 O'Clock Inflow

Pipe Height: **8.4** (in.) Rod and Bar (Angled)
Pipe Material: **Clay** ☐ Pipe Lined
Invert Depth: **7.45** (ft.) Flow Characteristics: **Slow**
Deposits: ☐ None ☒ **Mud** ☒ **Sludge** ☒ **Debris** ☒ **Grease**
Silt Depth: **3** (in.) Deposits Extent: **Medium**
Infiltration: **None** Pipe Seal Cond: **Unknown**

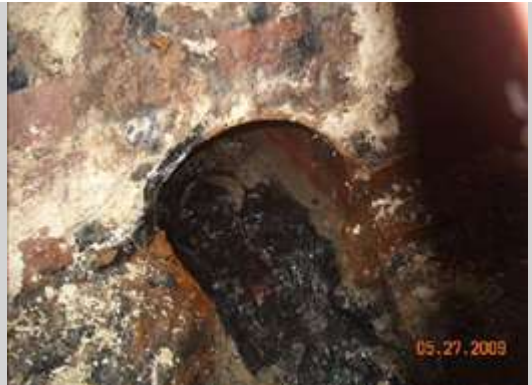
6 O'Clock Inflow

Deposits: ☐ None ☒ Mud ☒ Sludge ☒ Debris ☐ Grease

Silt Depth: **2** (in.) Deposits Extent: **Medium**

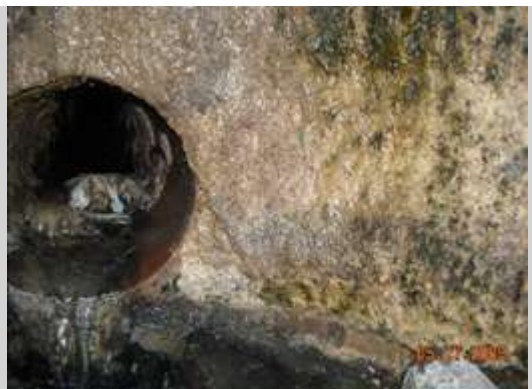
9 O'Clock Inflow

Deposits: ☐ None ☐ Mud ☐ Sludge ☒ Debris ☐ Grease

Silt Depth: **1** (in.) Deposits Extent: **Light**
